Fatal Crash Review Team

Report for May 20, 2025

**W 71st Street and Georgetown Road
RSA**

ROAD SAFETY AUDIT

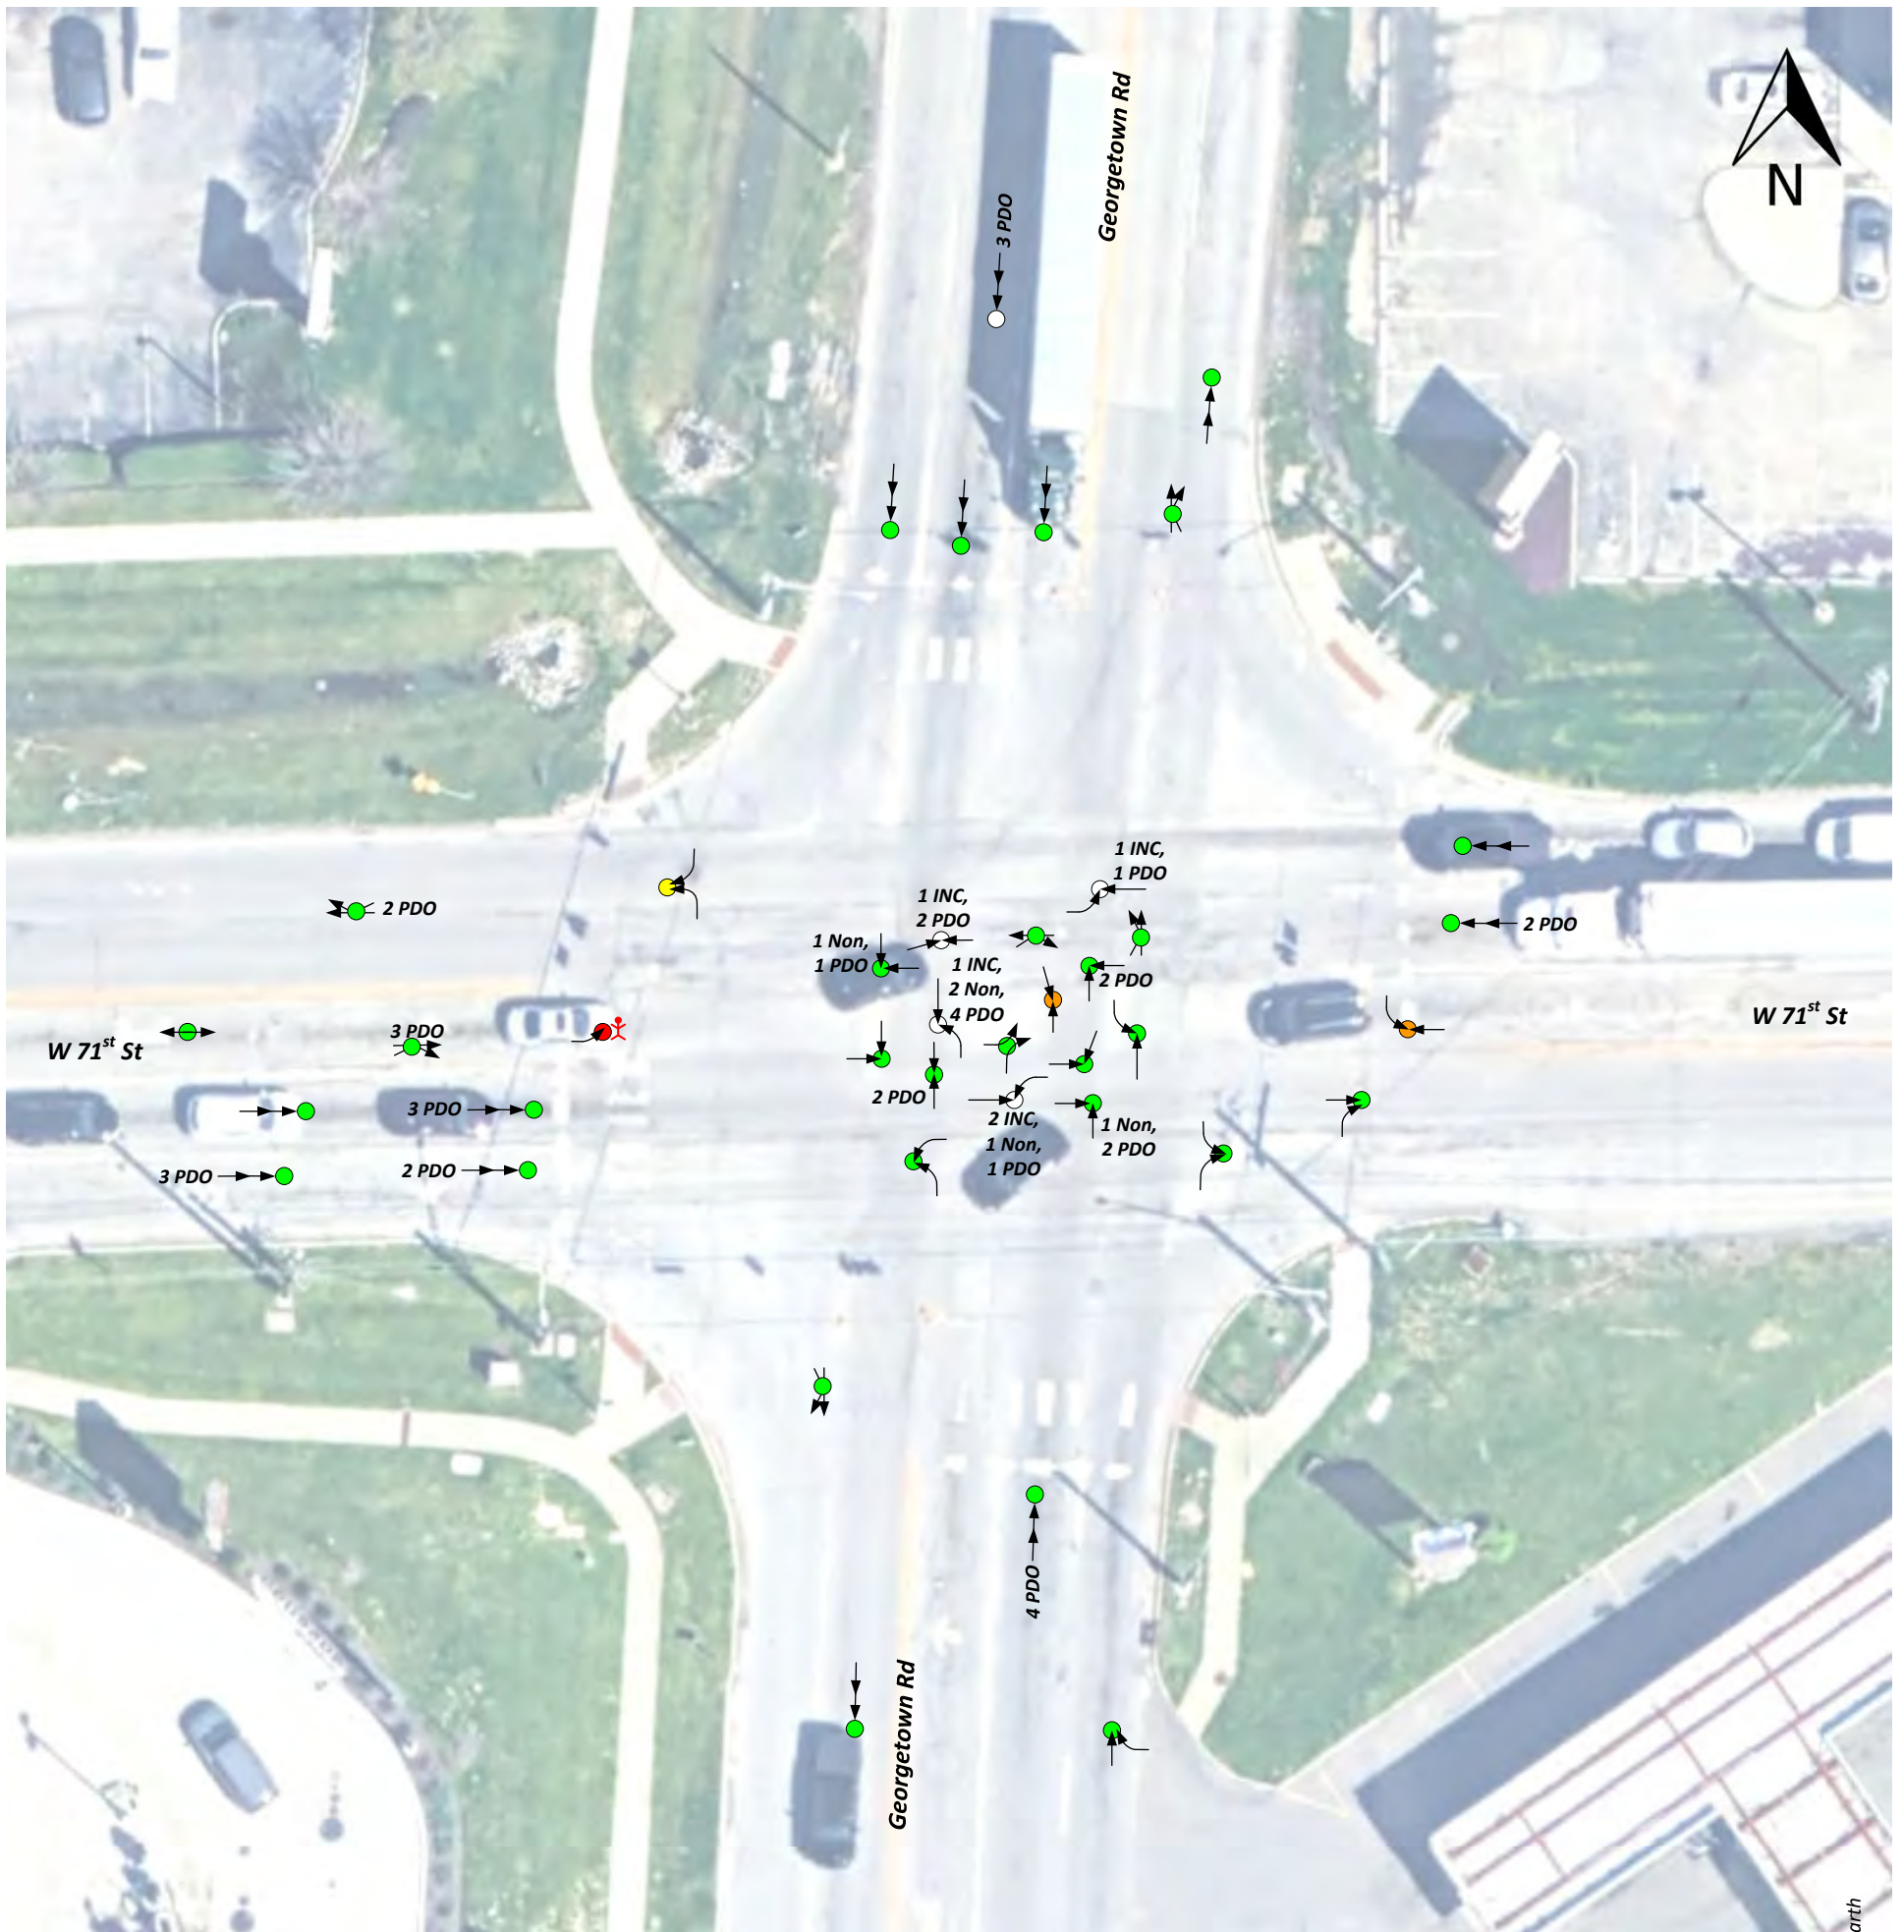
W 71st St. & Georgetown Rd. (Inset 1)

Study Period 1/1/2022 to 12/31/2024 Location: 7
 District: Greenfield County: Marion City/Town: Indianapolis
 Analyst: JB QC: JP Date: 4/2/25

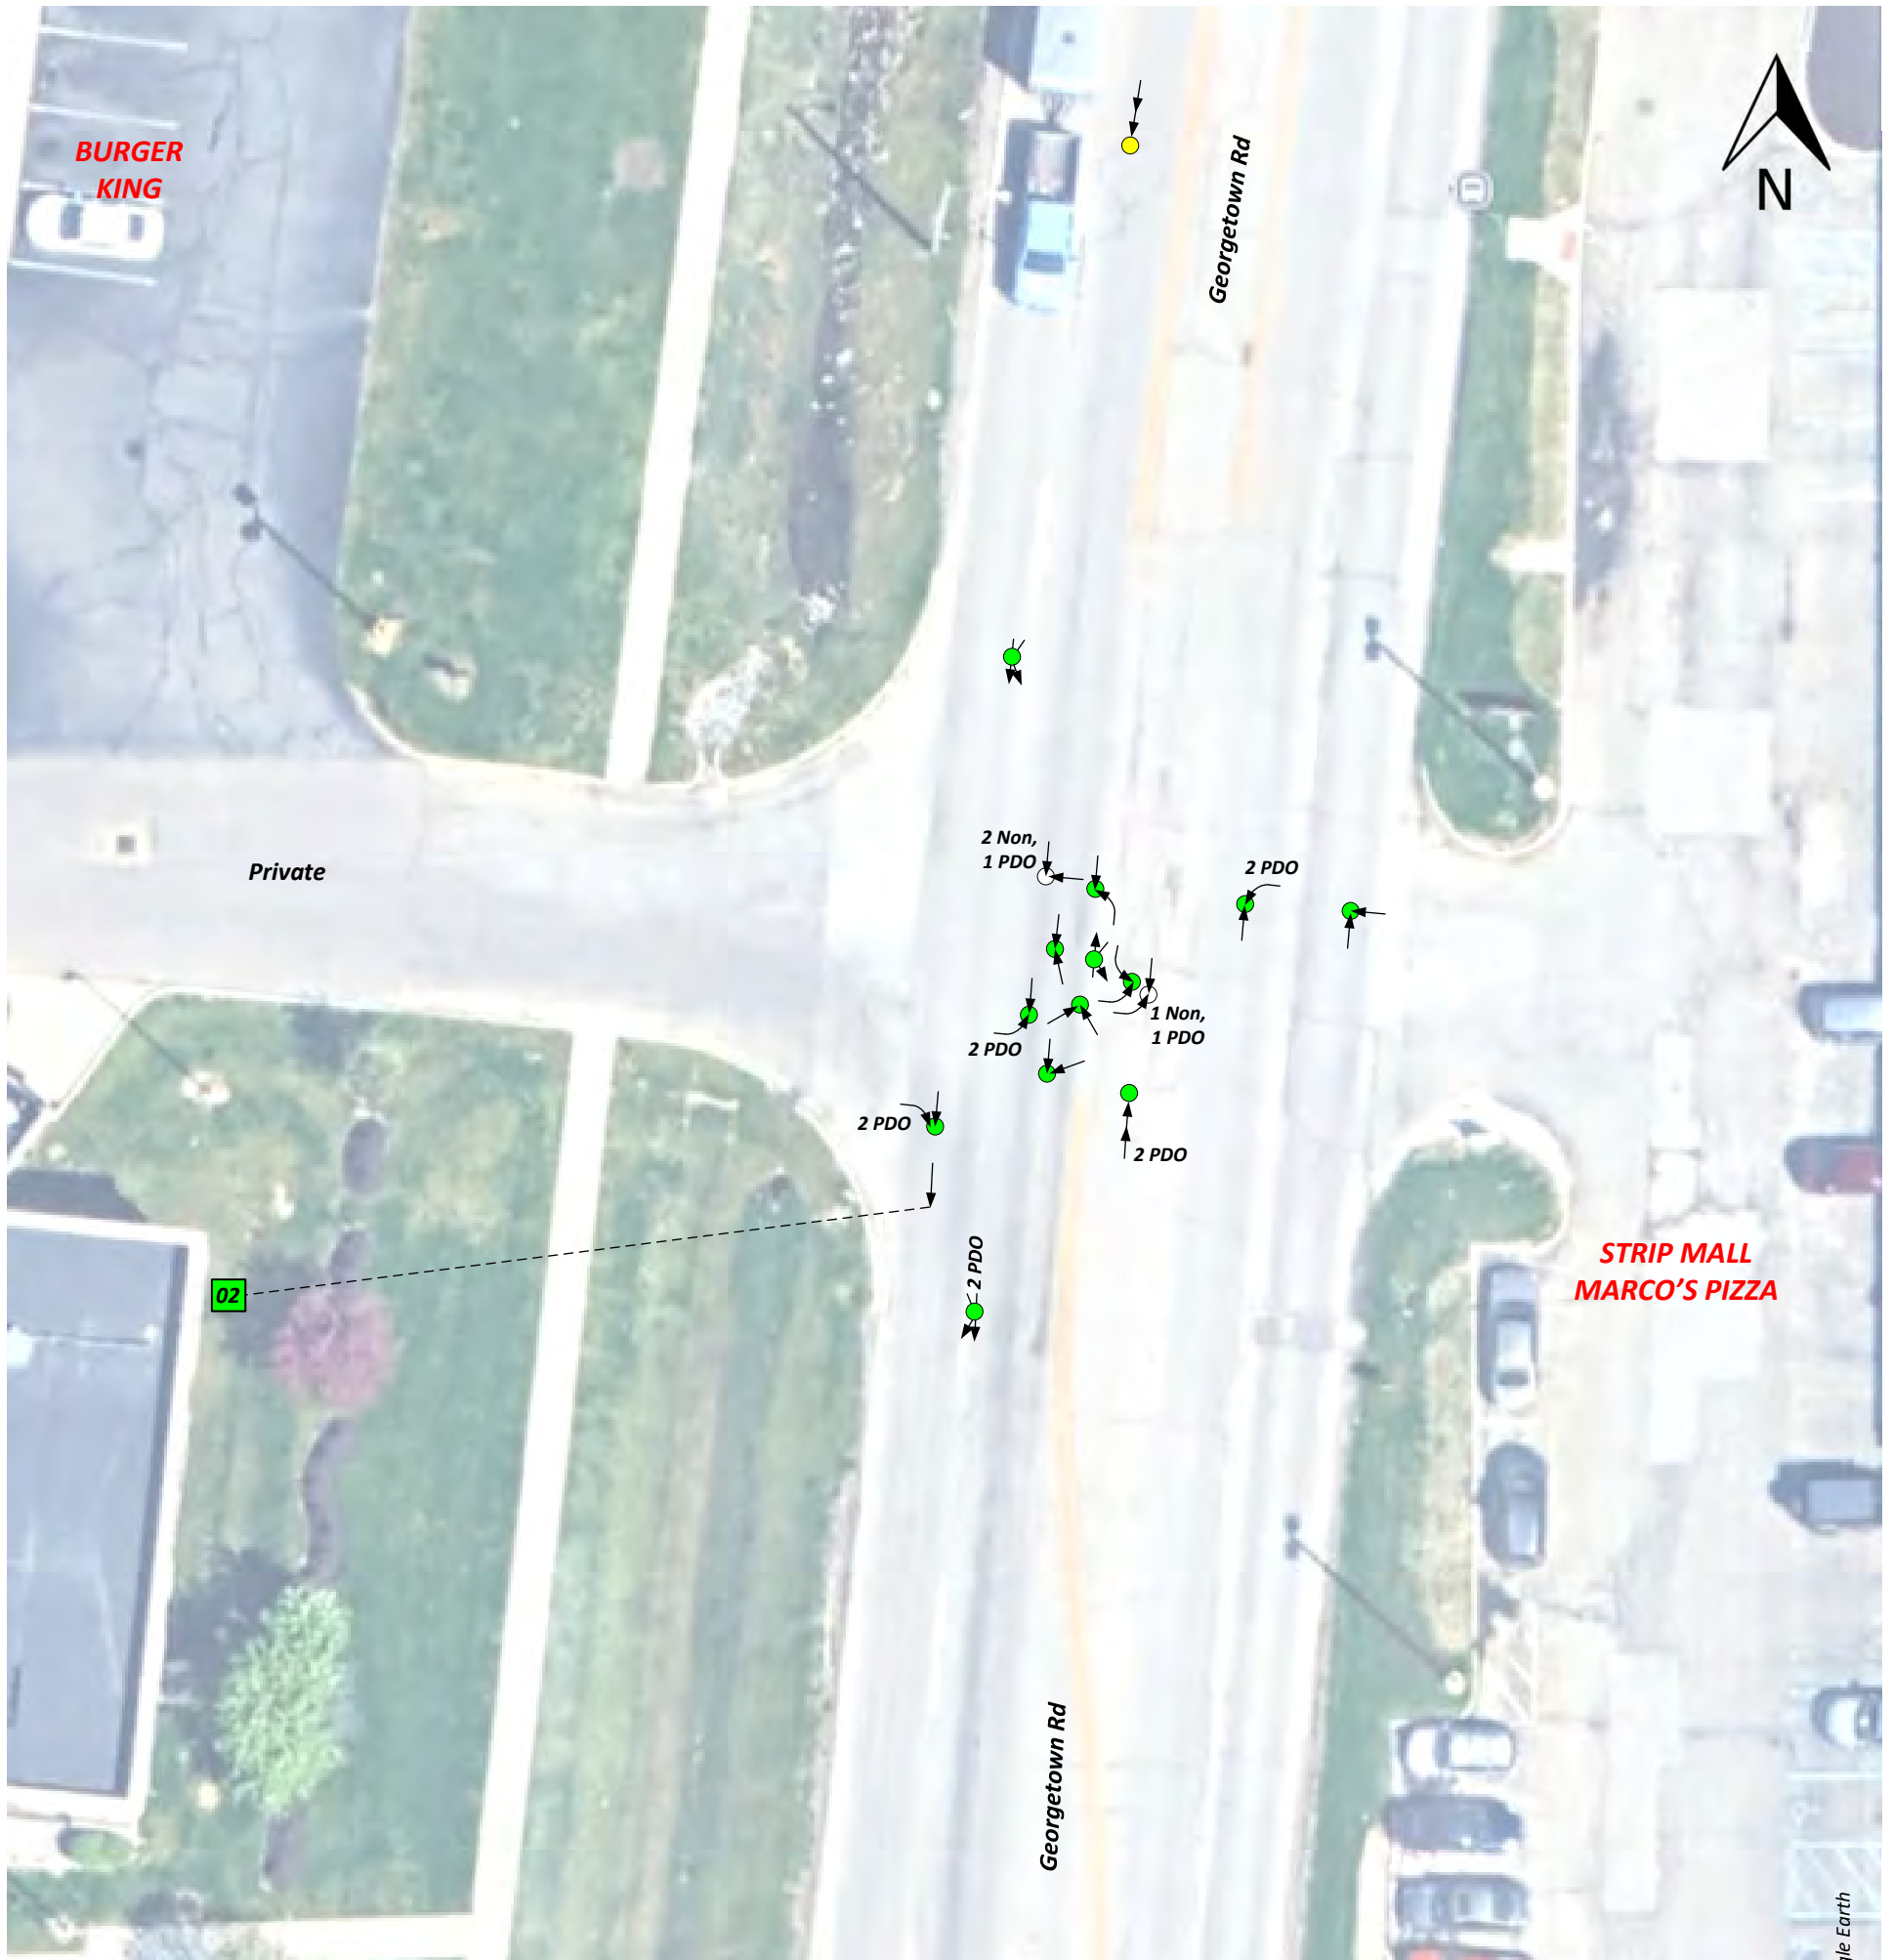
W 71st St. & Georgetown Rd. (Inset 2)

Study Period 1/1/2022 to 12/31/2024 Location: 7
 District: Greenfield County: Marion City/Town: Indianapolis
 Analyst: JB QC: JP Date: 4/2/25

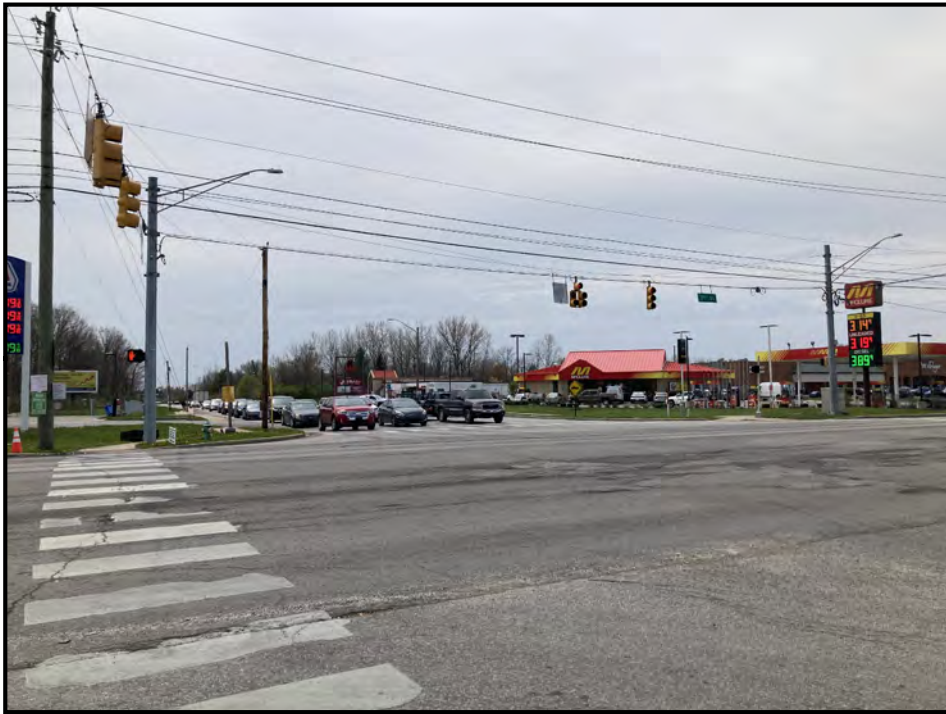
- The walk/wait signal for the pedestrian push button in the southeast corner is working sporadically.
- In the southwest corner the pedestrian push button is a "finger eater" and needs to be replaced.

SW quadrant

- All pedestrian hardware for this intersection should be investigated and any hardware determined to be faulty should be replaced. Under a full signal modification, all existing pedestrian signals should be modernized to meet the most current design standards including Accessible Pedestrian Signals (APS) push buttons.

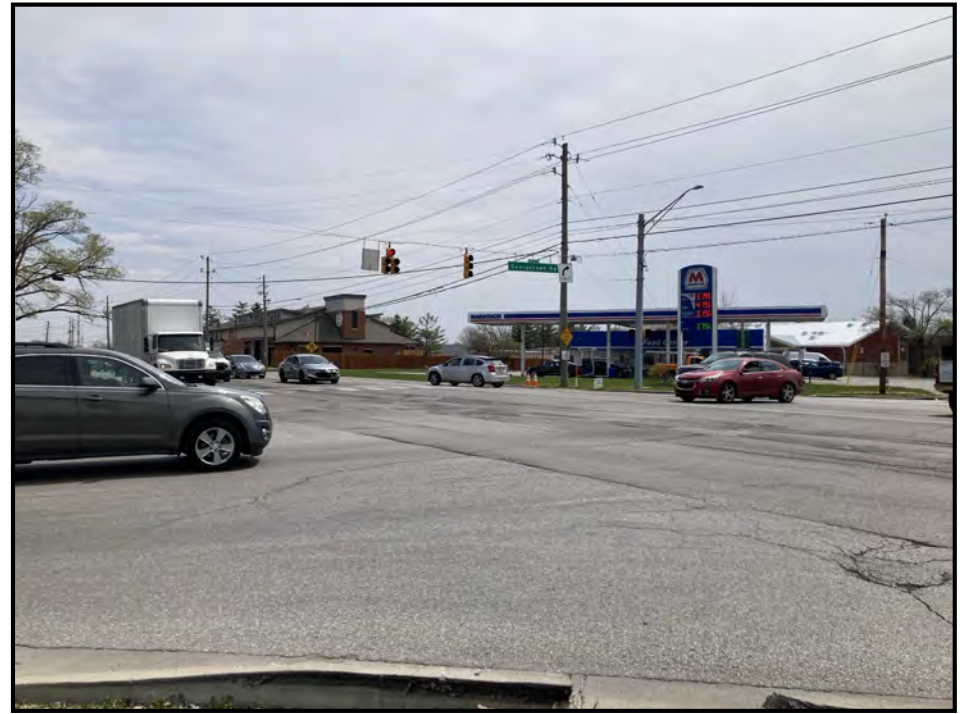
- A signal span wire is laying on ground on the southeast corner.
- There is evidence of trailer over tracking on the NE corner. Given that Park 100 industrial warehouse district is located north of this intersection, the radii for the north leg may be inadequate and should be checked with turning templates.

SE quadrant

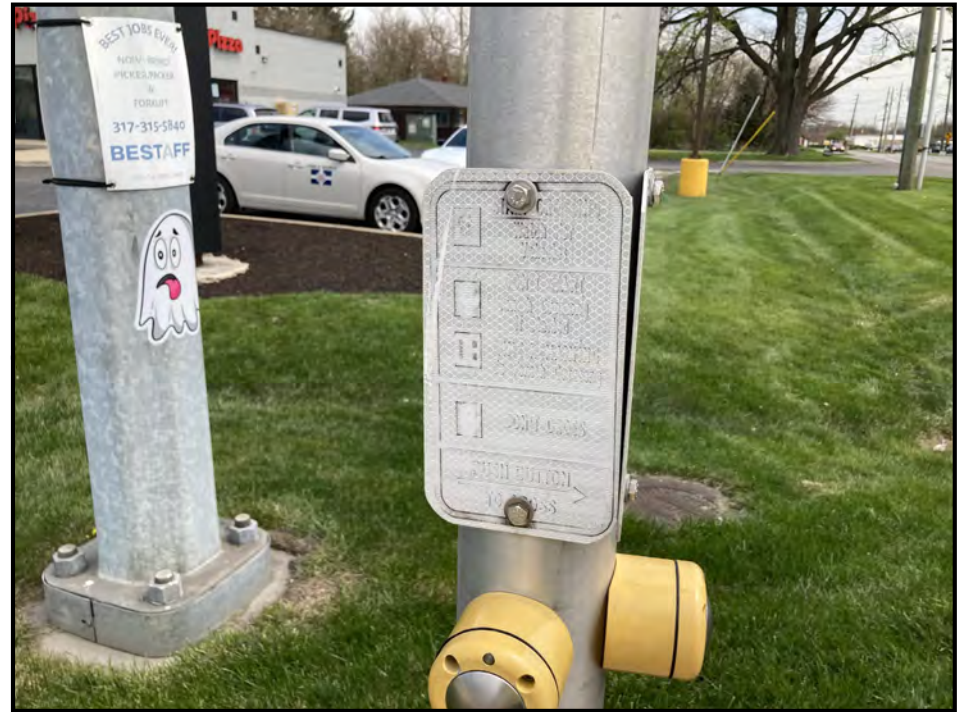
- The Pedestrian Signal Information sign (R10-3b) for the pedestrian crossing on the northeast corner for pedestrians crossing eastbound is damaged.
- A posted speed limit sign is not currently present on SB Georgetown Rd .

Pedestrian crossing sign (R10-3b) in NE Quad (Replace)

- Replace the existing Share the Road (W16-1) / Bicycle sign (W11-1) on the southeast corner.
- Replace the Pedestrian Signal Information sign (R10-3b) for the pedestrian crossing on the northeast corner for pedestrians crossing eastbound.
- Repair the signal span wire that is laying on ground on the southeast corner.
- Install a 40 mph Speed Limit sign (R2-1) on SB Georgetown Rd.
- Convert the existing protected/permitted left-turn 5-section doghouse signals to protected only for all directions to reduce left-turn / failure to yield crashes and improve safety at this intersection.
- Consider providing a Leading Pedestrian Interval (LPI) to protect pedestrians and bicyclists from drivers that may not see or be expecting them.
- Increase police presence to encourage drivers to avoid using cell phones while driving i.e. enforce the law that prohibits cell phone use while driving.

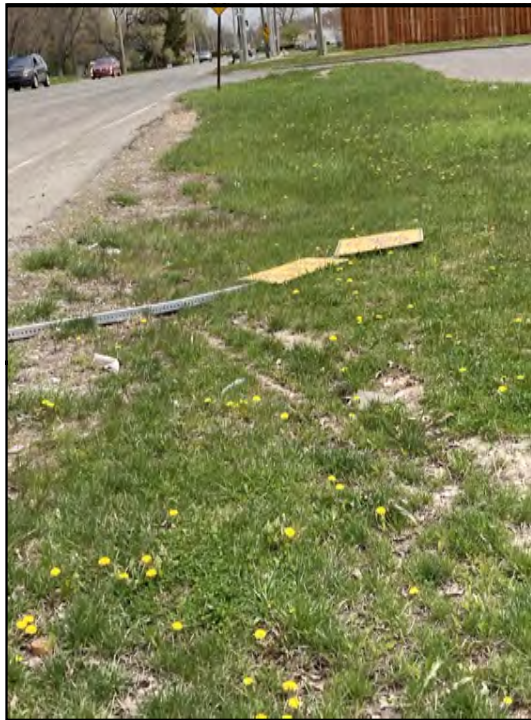
SE Quad Bicycle_Share the Road Knock Down

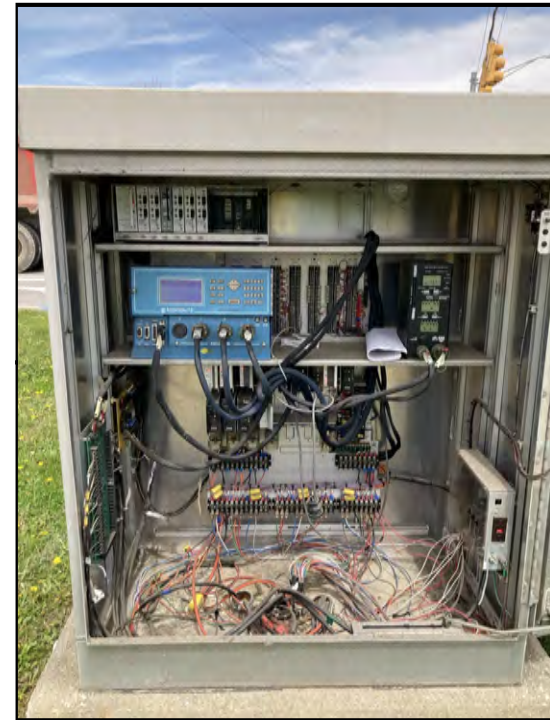
SW Quad Signal Cabinet
